Reduction and Mitigation of Thermal Injuries; What Can be Done

January 1996

**U.S. Army Aeromedical Research Laboratory
Fort Rucker, Alabama 36362-0577**

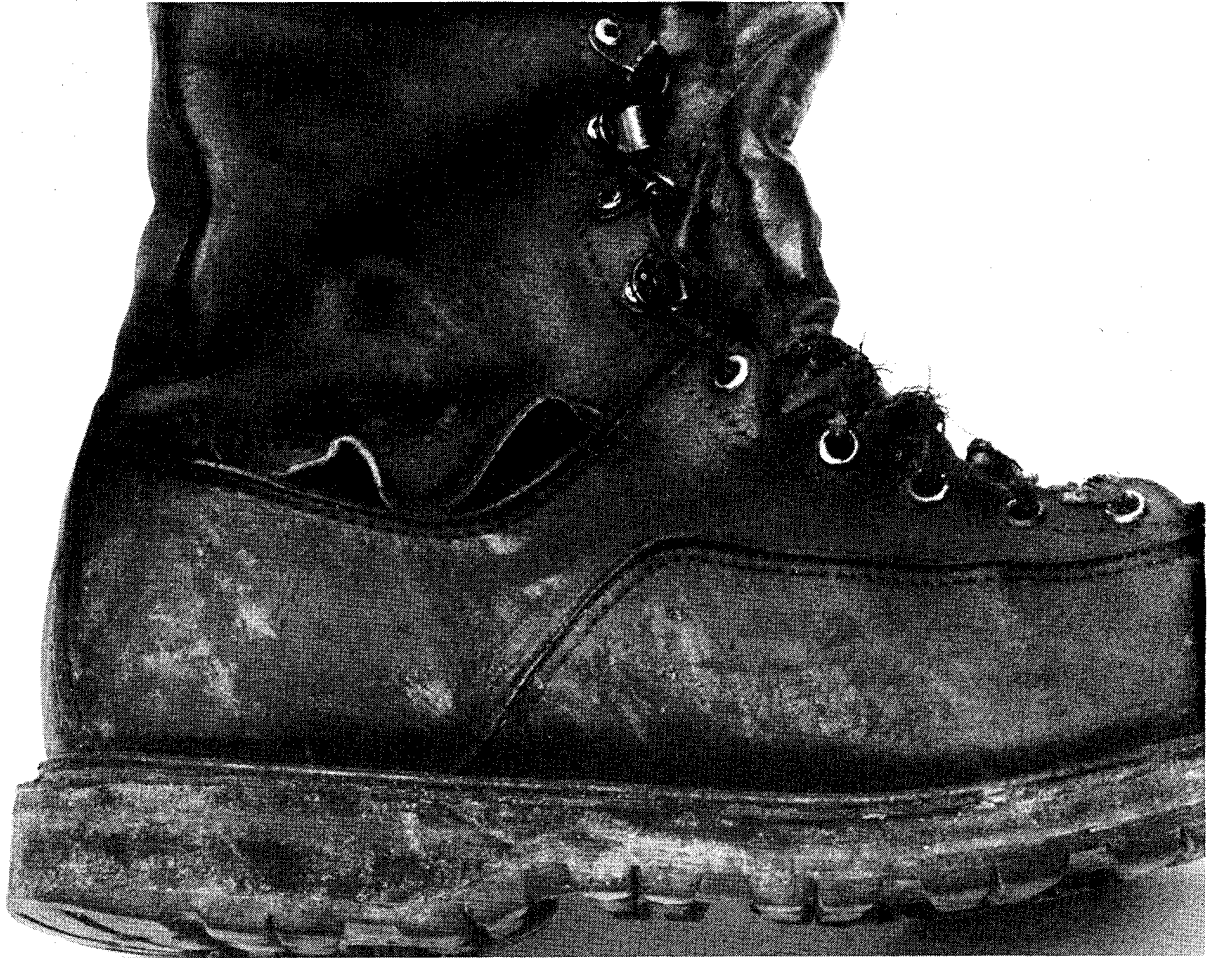
Figure 1. All leather boots provided 100% protection even when stitching burned and the seam failed.

The pilot was wearing leather boots, serviceable Nomex® flight suit, gloves, and jacket (with collar up) and helmet. Although on fire when he egressed, the ensemble worked as designed and the flame extinguished (Table 3).⁶ The flight jacket collar and right shoulder burned through the outer layer, but protected him from thermal injury. The stitching on his right boot burned through revealing the inner Gore Tex™ liner, yet protected his feet from injury (Figure 1). He received minor thermal injuries.

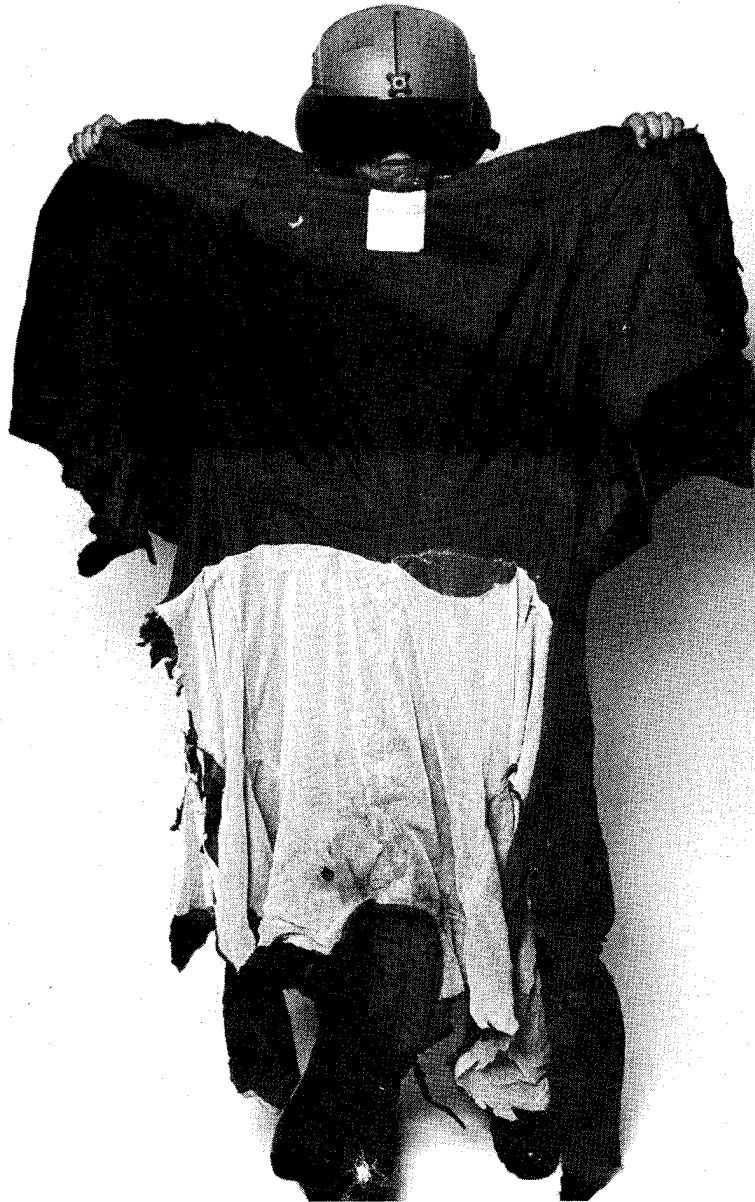
Figure 3. Nylon coveralls worn as an undergarment melted to the flight suit and the individual from the waist down.

The copilot egressed shortly after the pilot. He was wearing gloves with holes in numerous finger tips (Figure 2). As a result, the burns he received to his right hand caused permanent impairment. He also was wearing an Air Force approved flying coverall under his Nomex® flight suit. This Air Force item was not authorized by the Army for aviation use because it had a nylon lining. Where the coverall was covered by both the flight suit and flight jacket, it did not melt or burn. From the waist down, however, the heat and fire melted the coverall into the flight suit and the individual (Figure 3). The thermal injuries this individual received on his legs resulted in his disqualification from aviation and military duties.

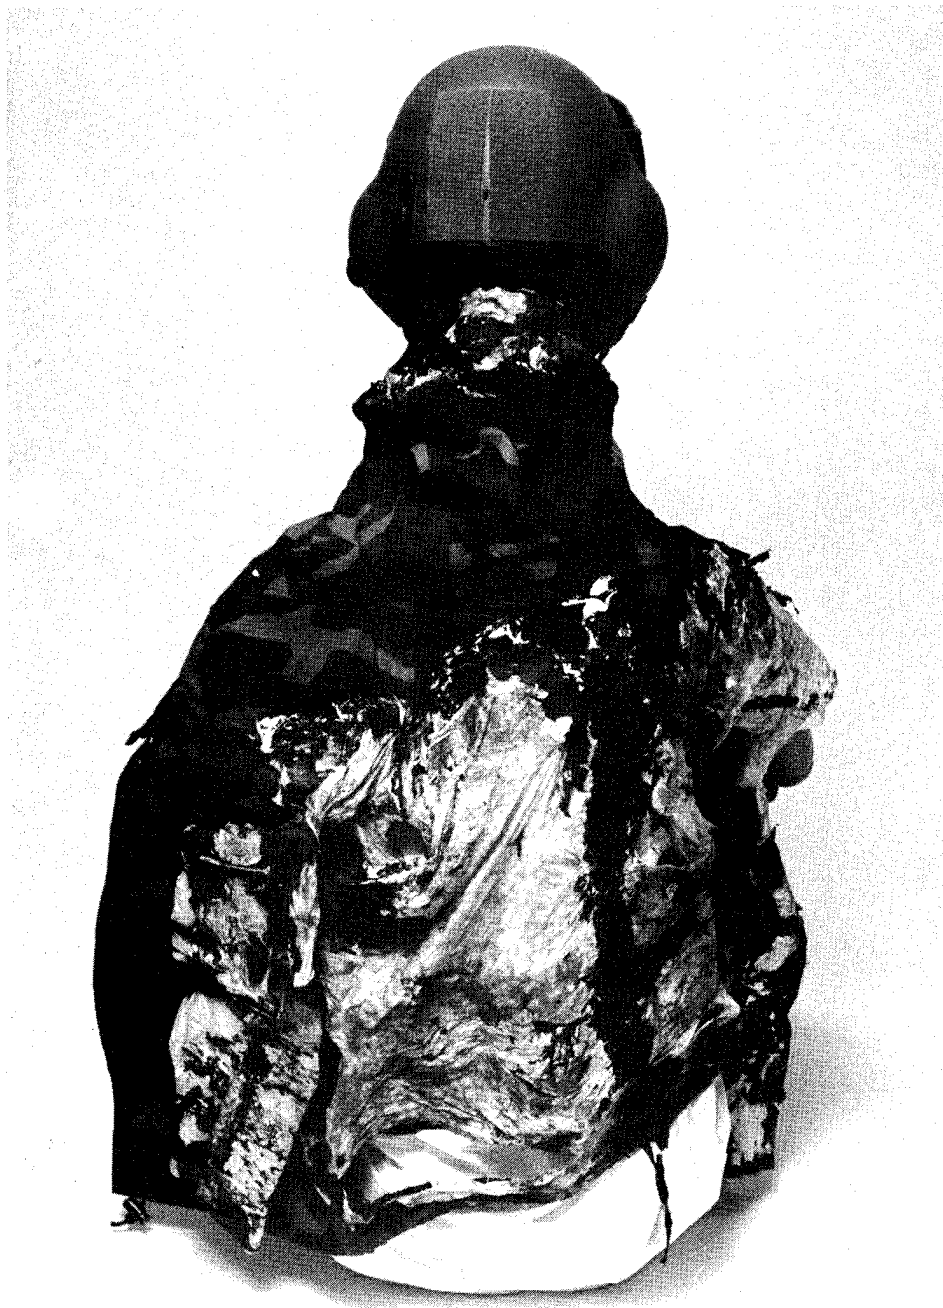
Figure 4. The Gore Tex™ field jacket, an item of issue, performed poorly in a fire as the inner and outer nylon shell melted to the individual.

One passenger egressed successfully only to return into the blaze to assist another passenger. He was wearing a battle dress uniform (BDU) and a Gore Tex™ field jacket (Figure 4). The Gore Tex™ material did not contribute to injury, but the jacket's nylon inner and outer shell burned and melted into the fabric of his BDU and his skin. He received major thermal injuries.
